DRAFT RESOURCE MANAGEMENT PLAN
**NATIONAL MONUMENT
TO THE FOREFATHERS**
PLYMOUTH, MASSACHUSETTS

February 2006

Massachusetts Department of Conservation and Recreation
Division of Planning and Engineering
Resource Management Planning Program

WALKER-KLUESING DESIGN GROUP
LANDSCAPE ARCHITECTS
144 LINCOLN STREET, BOSTON, MASSACHUSETTS 02111

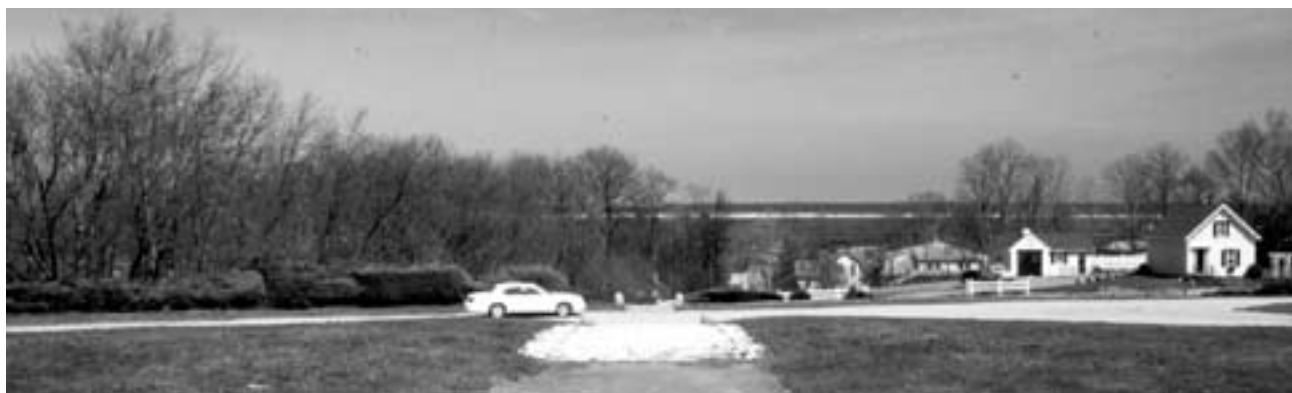
*Views to ocean from monument
in April 2005*

Improve Views to Ocean: The view toward Plymouth Bay can be restored only with the cooperation of the property owner whose trees interrupt the sight line. Because the view is so important to the design of the monument and the experience of visitors, the property owner should be contacted to see if they would be willing to have selected trees removed and replaced with lower growing trees.

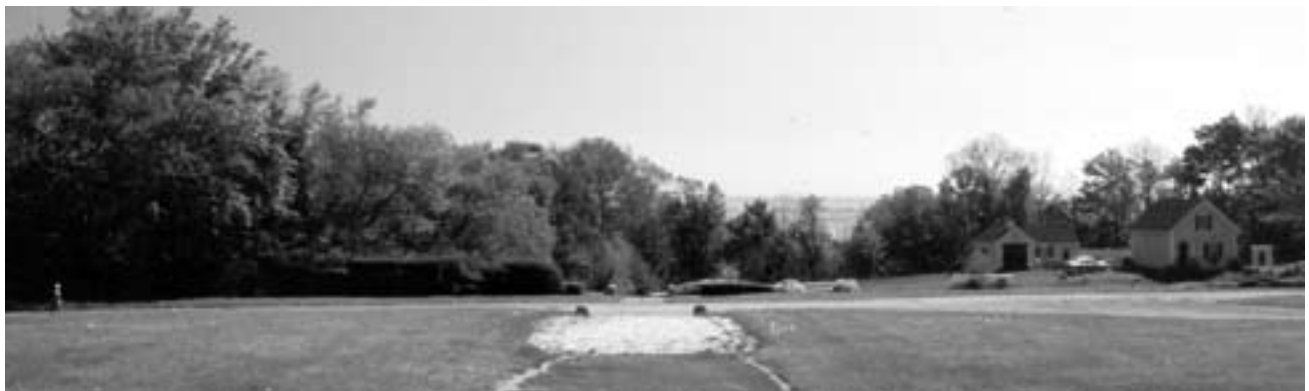
*Views to ocean from monument
in May 2005*

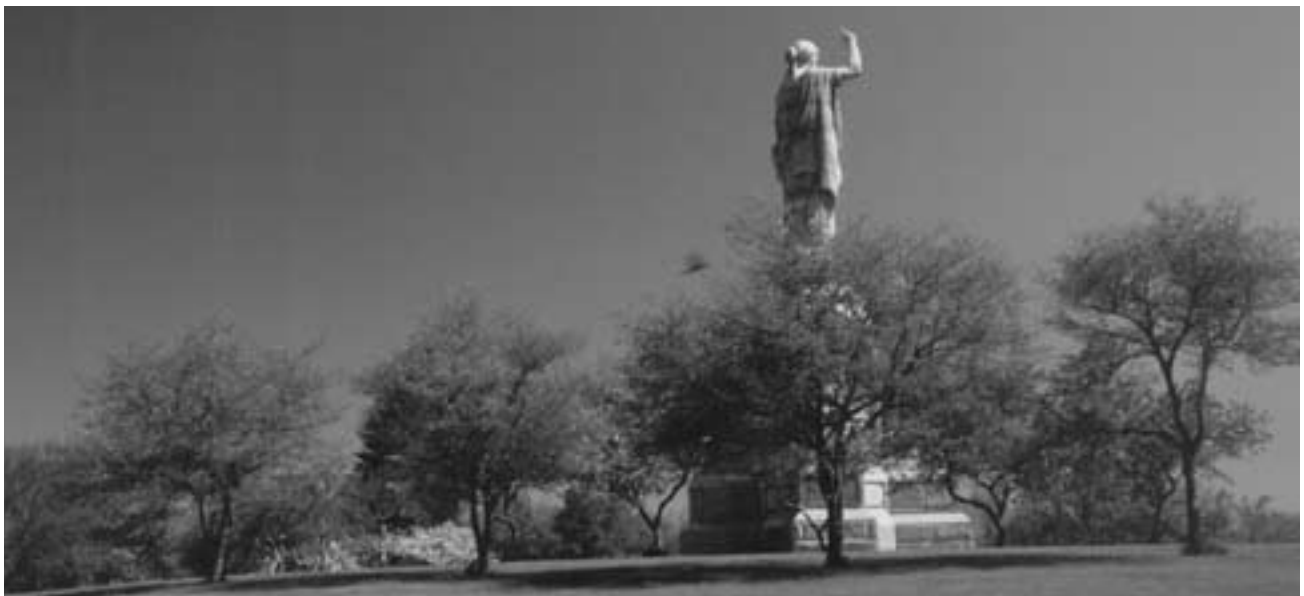
*Vegetation impeding view
of monument from rear*

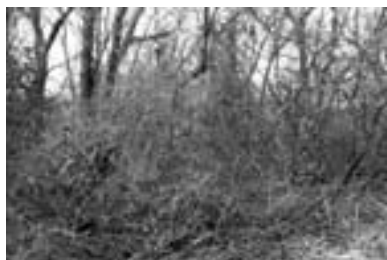
*Bull Brier,
invasive volunteer growth*

Commence a hazard tree mitigation program by removing volatile fuels [decayed matter on forest floor and underbrush] and public safety hazards [standing dead trees and dead limbs]. Remove the invasive volunteer growth. Many are weak wooded trees and they present a public safety hazard. Although difficult to eradicate, the invasive understory of Brier should also be removed. On steep slopes, clear and grub, then install desirable plants to control erosion. The use of appropriate seedlings is a cost effective way to reinvigorate wooded areas. Removal of invasive vegetation [brier, poison ivy, etc.] could be considered an appropriate volunteer project.

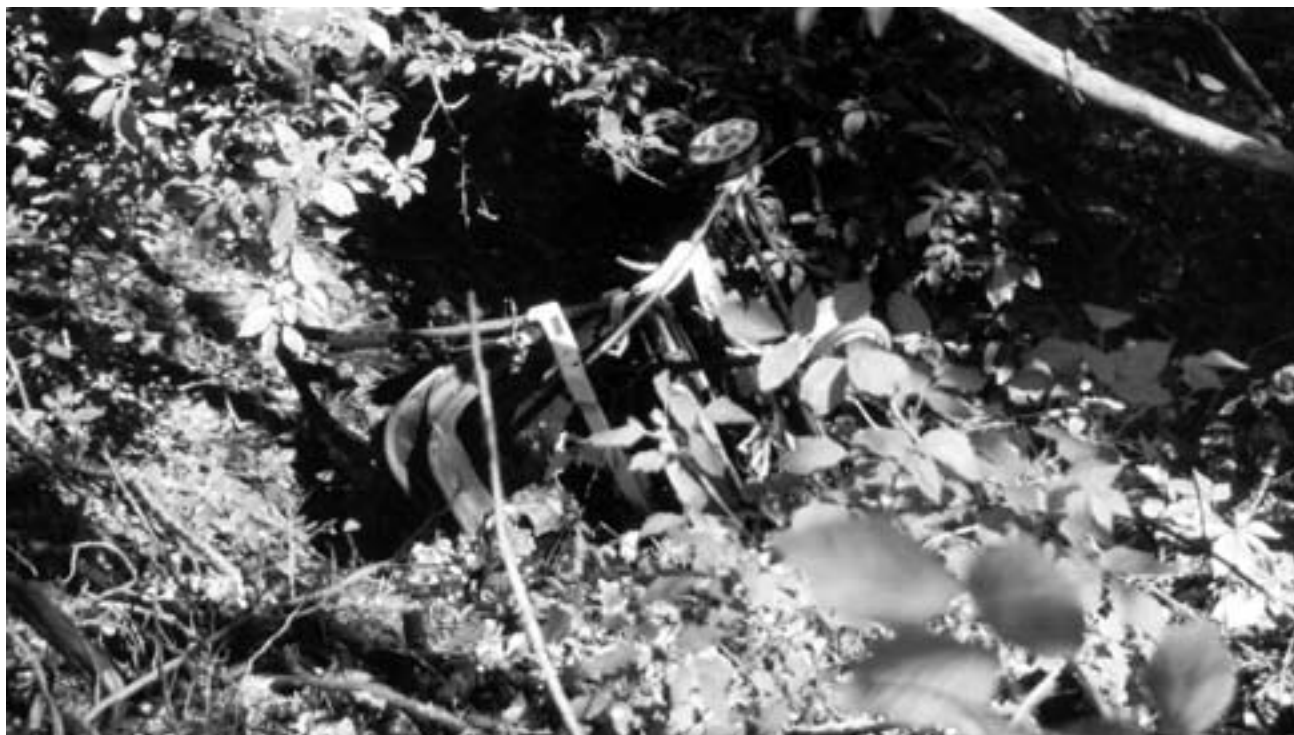
While much of the developed area of the site is clean and open, wooded areas on the site have apparently not been maintained in many years. The forest floor is littered with trash and debris on north, south and west sides. Tires, a baby carriage, household furnishings, crushed stone, debris piles, wood pallets and firewood were found as well as dead trees and trees with significant amounts of dead wood.

Trash and debris in the woods

New facilities should be placed outside the circular drive and screened from view with vegetation. Clean up wooded areas removing trash, debris and dead trees. Prune to remove hazardous dead wood.

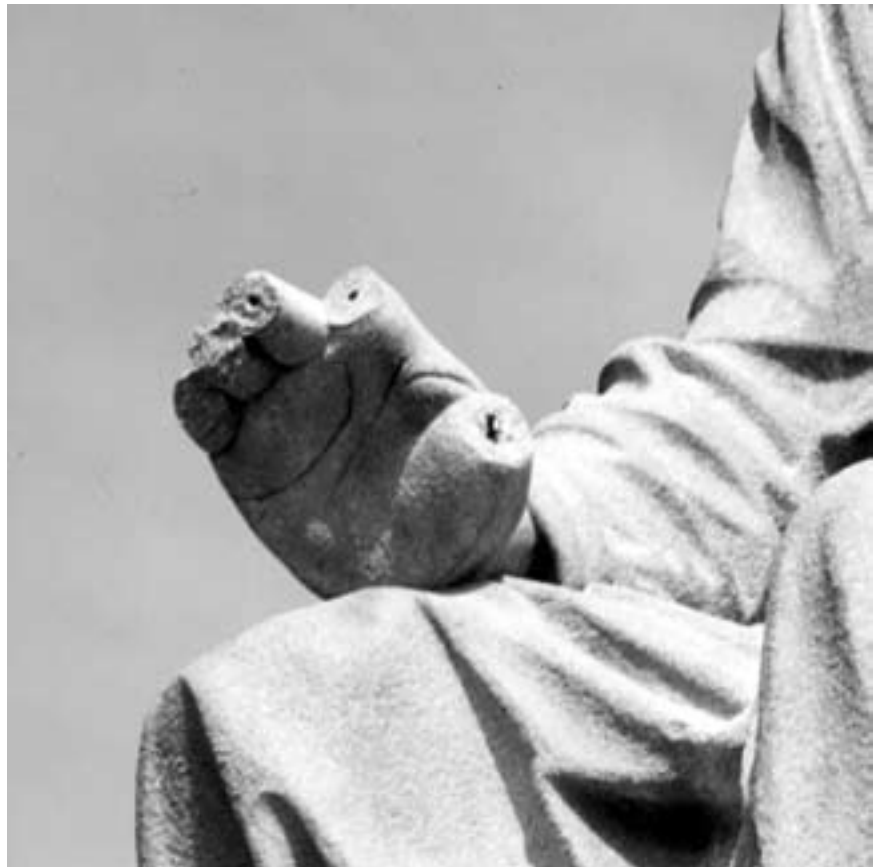
*Detail of lost fingers
at the figure Law*

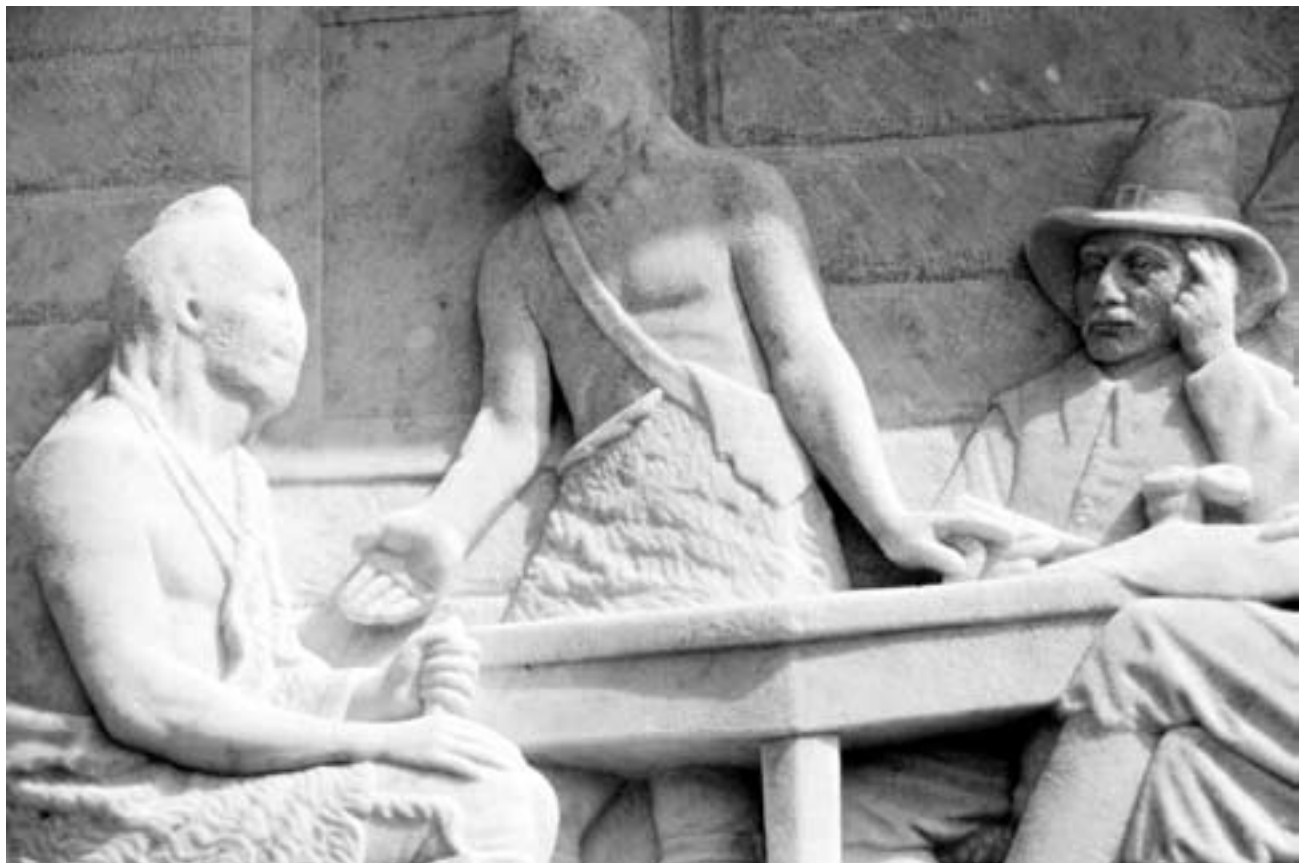
Landing at Plymouth [under Liberty]: This sculpture shows erosion at the most projecting surfaces, particularly the facial features. This type of weathering away of the crystals at the stone surface is referred to as sugaring which results in a roughened surface and loss of detail. The sugaring is most severe where the work is least shielded from wind, rain and salt spray. The edges and recessed areas are in better condition than the central area and projecting features. This tablet shows limited salt accumulation on the surface and has only limited fine cracks in the stone surface and has little surface soiling.

Detail of erosion at bas-relief

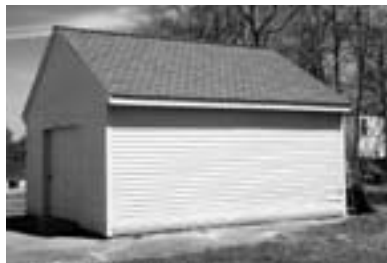
Existing Garage

The garage was built as a gift shop, probably in the late 1960s, and modernized as an equipment storage facility by the Department of Conservation and Recreation around 2001. This is the only building on the three sites maintained by this staff [the National Monument to the Forefathers, Plymouth Rock and the Myles Standish Monument in Duxbury]. Since it began serving as a place for equipment storage, staff travel time has reduced significantly. In good condition, it is a one story, one bay, concrete block building sided with wood clapboards and topped by a front gable, asphalt shingled roof. The facade has been damaged on southwest corner. This building has insufficient size for anticipated equipment storage needs.

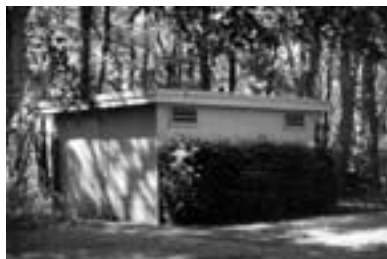
Existing Rest Rooms

The one story, flat roof, concrete block restroom facility, which likely dates from the same period as the garage, is located south of the garage and partially screened by a hedge. It is in poor condition and inoperable although there are water and sewer connections to the town system. No public services are provided by these buildings in their current state.

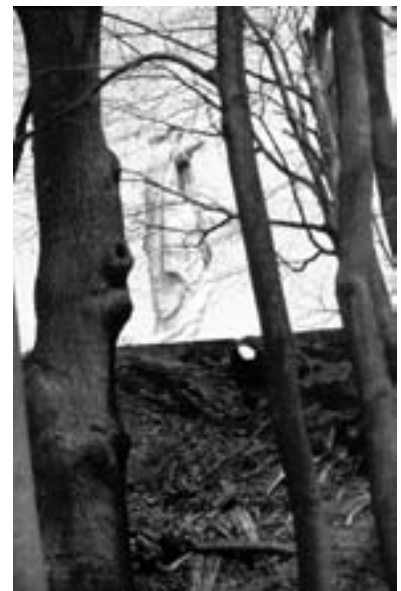
*Corrugated metal pipe
at the concrete curb
on the circular drive*

Replace Curbing with Barrier Rails: Remove the concrete curb and drainage structures on the outer edge of the circular drive and replace with an appropriate barrier rail that will provide a higher degree of public safety. This action will also significantly reduce down slope erosion conditions created by the curbing and drainage structures.

Erosion Repairs: Repair the erosion created by the point source discharges once the concrete curbing is removed.

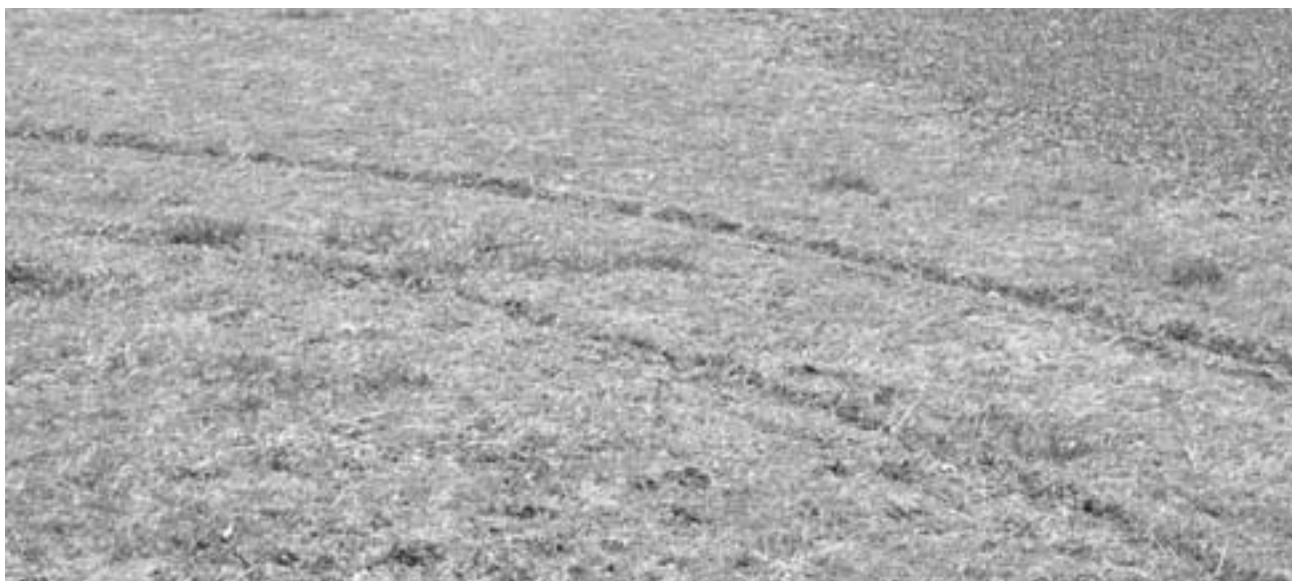
Tire ruts in lawn

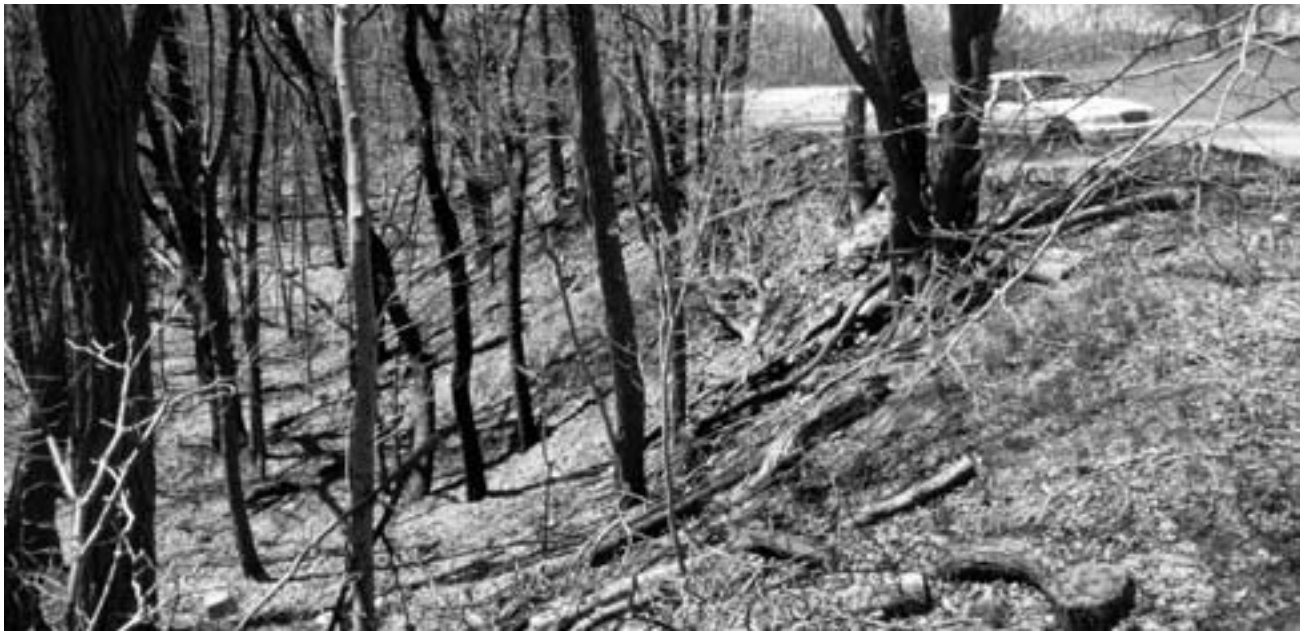
Steep slopes adjacent to circular drive
